SERVICE BULLETIN NO. 406

TITLE COCKPIT OXYGEN PLUMBING REVISION

PURPOSE ALLEVIATE CONGESTED CONDITION
BEHIND SIDE CONSOLE

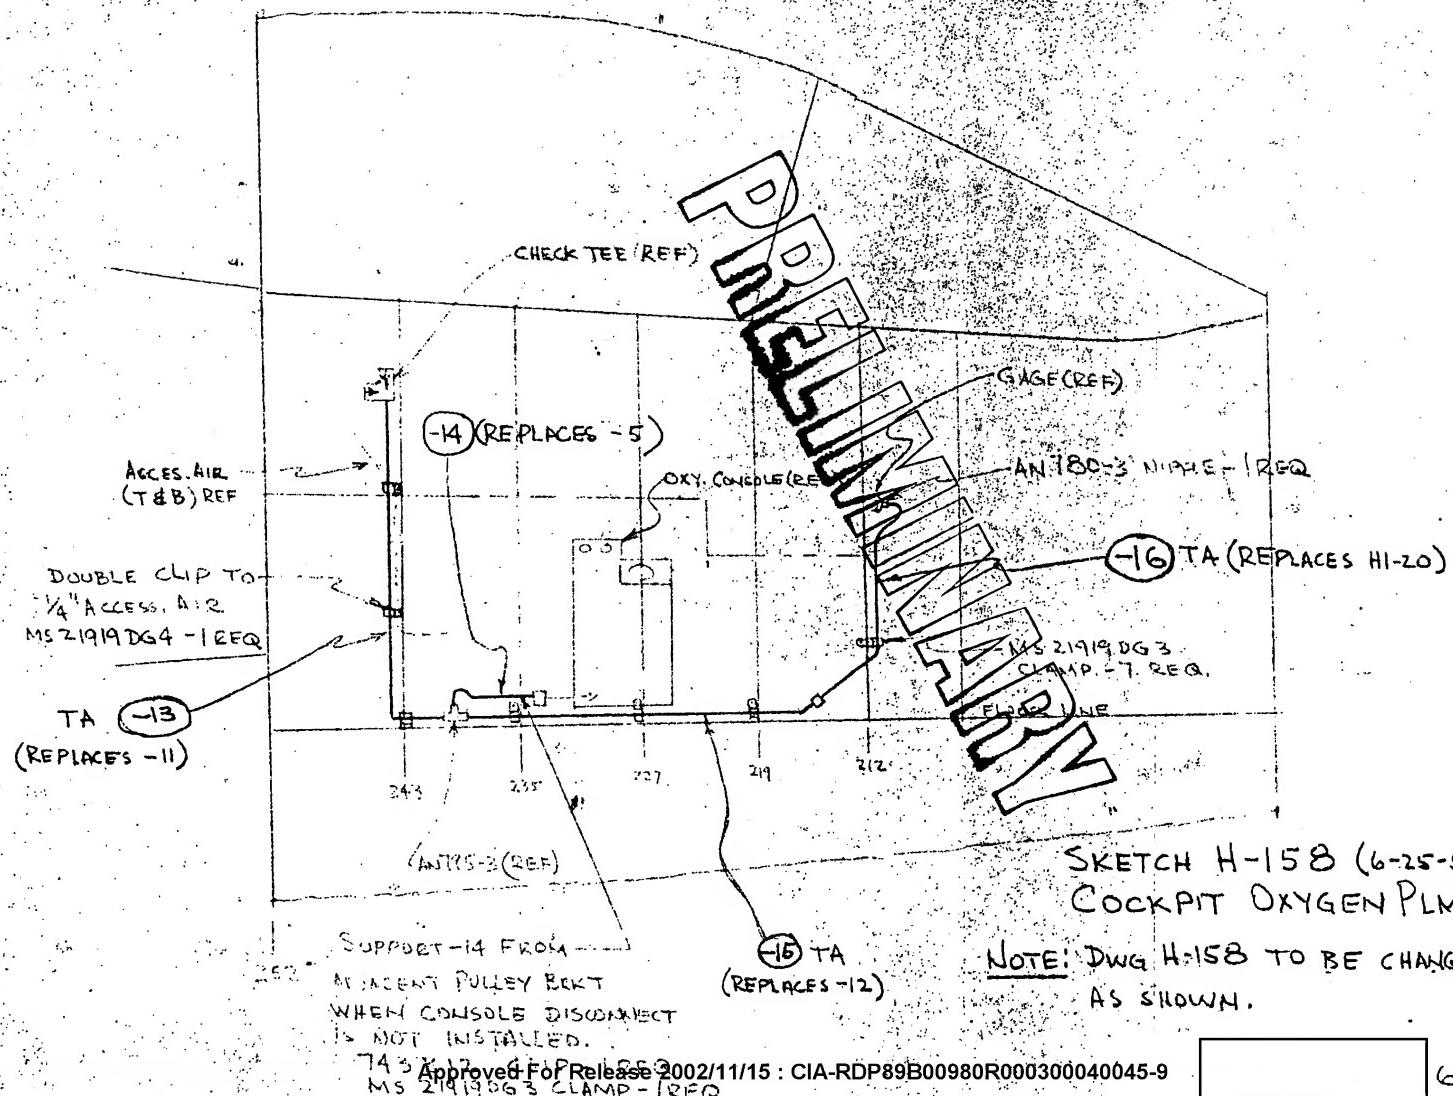
UR's THIS BULLETIN CORRECTS EMERG.
U.R. 59-189

1. Remove H158-11, -12, -5 & H1-20 Tubes
2. Install H158-13, -14, -15, & -16 Per Ref. Dwg.
3. Replace existing fitting in pressure gage with AN780-3 Nipple
4. At 1800 ± 100 psi, soap check all new & previously broken connections.
No leakage allowed.

NOTE: Leakage at bottle connection may require new O-Ring (P/N WK 200573)
